## **Effect of Gully Erosion on the Slope Parallel to the Al-Rujban Mountain Road NW Libya.**

Aboalgasem Alakhdar<sup>\*</sup>

Geological Engineering Department, Faculty of Engineering jado, Nalut University, Libya

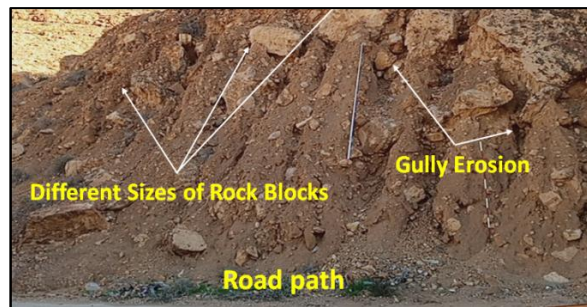
**Figure 2:** Gully Erosion On study area

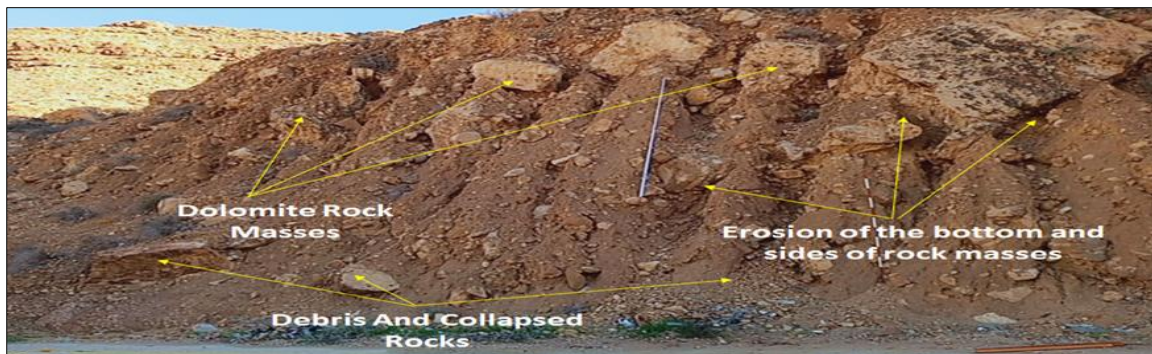
The studied slope consists of rocky debris of various sizes, primarily composed of limestone, clay, and marl rocks from the Sidi as Sid Fm of the Ain Tabi Member. During excavation, these rocks were displaced, and the debris was used to form a new artificial slope made of soil, clay, and rock blocks. The grooves observed in the slope reflect the effect of rainfall, which contributed to lateral erosion of the grooves, removing soil and debris from the sides and bottoms of the rock blocks Figure 9. This erosion, affects the stability of the rock blocks, soil,

and clay, particularly in the absence of protective concrete barriers. Additionally, gully erosion has altered the slope's geometry, with an inclination angle of  $35^\circ$  within the gullies, indicating the strong impact of this process. The Gully Erosion Rate (GER) is  $3733 \times 10^{-7} \text{ m}^3/\text{m}^2/\text{year}$ , which is categorized as "very weak" Table 3, meaning the rate of material loss is relatively slow and does not result in the formation of new gullies or channels.

**Figure 9:** Section of the Slope Affected by Gully Erosion

This suggests that the erosion is gradual and continuous, but not significant enough to cause rapid collapses or drastic changes to the slope in the short term. Moreover, the gullies have contributed to the formation of new stabilizing angles within the slope. However, the greatest risk lies in the potential collapse of large and medium-sized rock blocks that are currently stabilizing the slope, especially within the gullies. It is expected that continued erosion over time will lead to the collapse of these rock blocks, particularly with external factors like rainfall. Additionally, the mud and collapsed debris have blocked the water drainage channels parallel to the road path Figure 9, some of the rock blocks have collapsed, serving as an indicator of the weakened state of the slope. The field study reflects the impact of geomorphological and Hydrological factors on the stability of the studied slope. This is consistent with the results of the laboratory tests conducted using the direct shear device. Laboratory data indicate that increasing the water content from 17% to 25% led to a decrease in cohesion from  $104 \text{ t/m}^2$  to  $51 \text{ t/m}^2$  Table 4, while the internal friction angle decreased from  $22.2^\circ$  to  $16.5^\circ$ . This finding is directly related to the field study results, which showed that the flow of water inside the gullies caused erosion of their sides, removing soil and debris. This erosion led to the collapse of rock blocks, soil, and clay, particularly in the absence of concrete barriers. These observations are consistent with the laboratory results, which indicated that an increase in water content reduces shear strength and increases the risk of collapses. This makes large and medium-sized rock blocks, located either on the slope or inside the gullies, more susceptible to future collapse. Moreover, the laboratory data confirmed that the low internal friction angle of  $16.5^\circ$  Table 4 reflects the weak resistance of the slope components to collapse. This is connected to the changes in slope geometry, as the angle of inclination inside the gullies reached  $35^\circ$ , suggesting that gully erosion plays a major role in reshaping the slope's topography and affecting its

stability. The closure of drainage channels parallel to the road due to debris is consistent with the effect of increasing pore pressure from the high water content, which leads to the disintegration of soil and rock debris. Consequently, the accumulation of eroded materials in low-lying areas may further increase the risk of future collapses due to poor water drainage. The data in Table 6 present a slope analysis using Rocplane software.

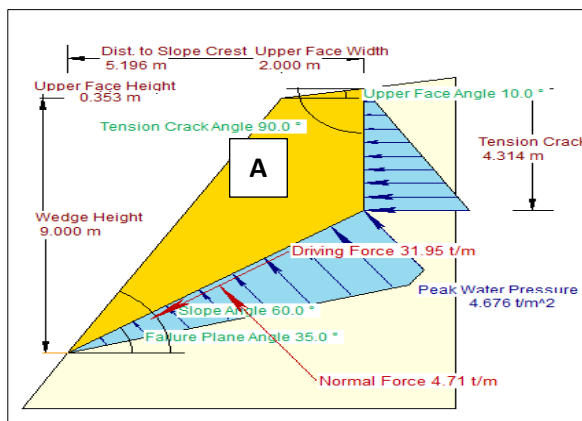
In Case-A, Figure 10, the slope unaffected by erosion, indicating good stability at this location. The Water Quantity in this case was 30 mm, which is relatively low and helps maintain stability. Additionally, the vertical force was 47.106 t/m, reflecting a moderate weight effect on the slope. Furthermore, the resistive force in Case A was the highest 932.8 t/m among all cases, contributing to greater stability. The safety factor reached 2.9 confirming that the slope in this case is stable, Table 5.

**Figure 10:** Slope Unaffected by Erosion at 30mm

On Figures 10 and 11, It is observed that the effect of water pressure is concentrated in two locations. The first is in the vertical direction (tension crack - 90°, Table 1), extending from the top surface to a depth of 4.31 m. This position is considered a weak point behind the wedge and can only be observed in the field. The second place of water pressure concentration is on the failure plane, where the pressure value varies depending on the amount of water. In case A, the water pressure is 4.676 t/m³, while in case B, it is 8.41 t/m³.

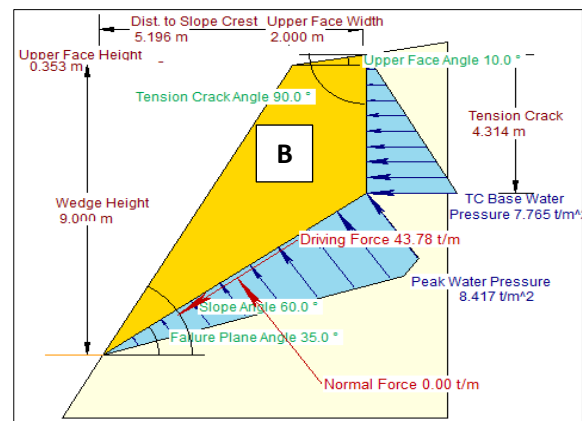
**Figure 11:** Slope Unaffected by Erosion at 60mm

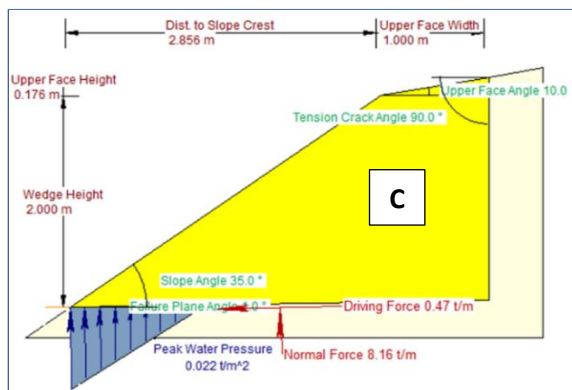
In Case-C, Figure 12, the slope was affected by gully erosion, with a water amount of 30 mm, the same as in Case A. The vertical force was 8.16 t/m, indicating a greater weight on

the slope compared to Case A. However, the resistive force was lower than that in Case A, suggesting that stability was slightly affected by erosion. Nevertheless, the safety factor in this case was significantly high (92.39), indicating that the slope is stable Table 5.

**Figure 12:** Slope affected by gully Erosion at 30mm

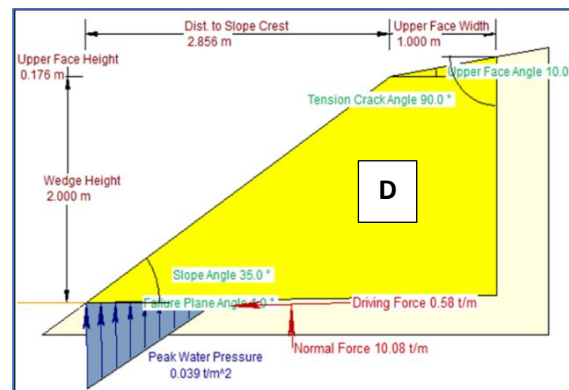
In Case-D, Figure 13, the slope affected by gully erosion, with a Water Quantity of 60 mm, similar to that in Case B. The vertical force in this case was 10.07 t/m, indicating greater pressure on the slope due to weight. However, the resistive force was 2,266 t/m, which is lower than in Case A, suggesting that the slope is relatively weak. Nevertheless, the safety factor in this case was 39.01, indicating relatively good stability compared to Case B.

**Figure 13:** Slope affected by gully Erosion at 60mm
