Effect of Gully Erosion on the Slope Parallel to the Al-Rujban Mountain Road NW Libya.

Aboalgasem Alakhdar*
Geological Engineering Department, Faculty of Engineering jado, Nalut University, Libya

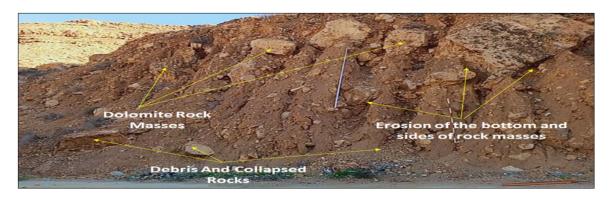
Figure 9: Section of the Slope Affected by Gully Erosion

these rocks were displaced, and the debris was used to form a new artificial slope made of soil, clay, and rock blocks. The grooves observed in the slope reflect the effect of rainfall, which contributed to lateral erosion of the grooves, removing soil and debris from the sides and bottoms of the rock blocks Figure 9. This erosion, affects the stability of the rock blocks, soil, and clay, particularly in the absence of protective concrete barriers. Additionally, gully erosion has altered the slope's geometry, with an inclination angle of 35° within the gullies, indicating the strong impact of this process. The Gully Erosion Rate (GER) is 3733×10^{-7} m³/m²/year, which is categorized as "very weak" Table 3, meaning the rate of material loss is relatively slow and does not result in the formation of new gullies or channels.

This suggests that the erosion is gradual and continuous, but not significant enough to cause rapid collapses or drastic changes to the slope in the short term. Moreover, the gullies have contributed to the formation of new stabilizing angles within the slope. However, the greatest risk lies in the potential collapse of large and medium-sized rock blocks that are currently stabilizing the slope, especially within the gullies. It is expected that continued erosion over time will lead to the collapse of these rock blocks, particularly with external factors like rainfall. Additionally, the mud and collapsed debris have blocked the water drainage channels parallel to the road path Figure 9, some of the rock blocks have collapsed, serving as an indicator of the weakened state of the slope. The field study reflects the impact of geomorphological and Hydrological factors on the stability of the studied slope. This is consistent with the results of the laboratory tests conducted using the direct shear device. Laboratory data indicate that increasing the water content from 17% to 25% led to a decrease in cohesion from 104 t/m² to 51 t/m² Table 4, while the internal friction angle decreased from 22.2° to 16.5°. This finding is directly related to the field study results, which showed that the flow of water inside the gullies caused erosion of their sides, removing soil and debris. This erosion led to the collapse of rock blocks, soil, and clay, particularly in the absence of concrete barriers. These observations are consistent with the laboratory results, which indicated that an increase in water content reduces shear strength and increases the risk of collapses. This makes

excess moisture raises landslide risks, especially without proper drainage. Hydrological factors significantly affect stability, as large water volumes alter slope forces. Despite its "very weak" erosion rate, gully erosion causes gradual instability, posing a long-term collapse risk. The study recommends regular monitoring and removal of unstable rock masses
