## **Effect of Gully Erosion on the Slope Parallel to the Al-Rujban Mountain Road NW Libya.**

Aboalgasem Alakhdar<sup>\*</sup>

Geological Engineering Department, Faculty of Engineering jado, Nalut University, Libya

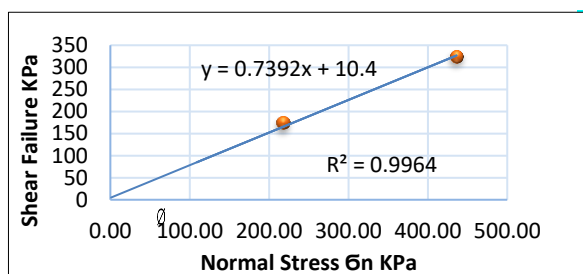
**Figure 5:** Relationship between normal & shear stress

- Laboratory study phase:** A sample of rock debris from a slope affected by gully erosion was collected at a depth of 30 cm and transported to the lab. The sample was dried in an oven at  $120^\circ\text{C}$  for 24 hours, and then 30 mm of water was added for homogenization. Vertical and shear stress tests were performed using a direct shear apparatus with a loading rate of  $0.25 \text{ N/s}$  and a  $36 \text{ cm}^2$  loading frame, as described in reference [21]. The test aimed to determine cohesion and friction angle, with the linear relationship between normal and shear stress recorded using a pre-prepared Excel curve (Figure 5). The test was conducted with three weights (4 kg, 8 kg, and 16 kg) (Figure 6). According to reference [21], a collapse of the rock debris occurred at a water volume of 80 mm, with internal saturation reaching 65%, leading to the loss of internal cohesion and a value of  $0 \text{ t/m}^2$ . The extracted values for (C and  $\phi$ ) are listed in Table 3, and these data are essential for input into the RocPlane program.

The same tests were repeated on the original specimen with the addition of 60 mm of water. The results from the laboratory study are listed in Table 3. Direct shear tests are influenced by factors such as rock type, surface roughness, water presence, and pore pressure [22].

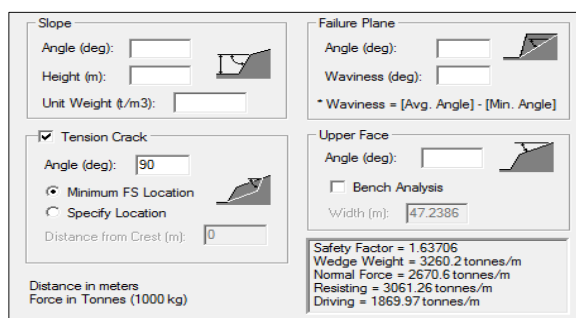
**Figure7:** Inputs Geometry Slope

- RocPlane software phase:** An interactive software tool for assessing the stability of slope components. The tool enables users to estimate the required support to achieve a specific safety factor in slope analysis and design by generating 2 and 3D models [23]. Figure 7. The software relies on several inputs, including: Slope geometry Figure 7, based on the data listed in Table 1. Cohesion and friction angle Figure 8, listed in Table 4. External forces, such as water pressure and the seismic coefficient of the study area [24].
